FLASH

Factual Lines About Submarine Hazards

Submarine Division of the Naval Safety Center

APRIL - JUNE 2012

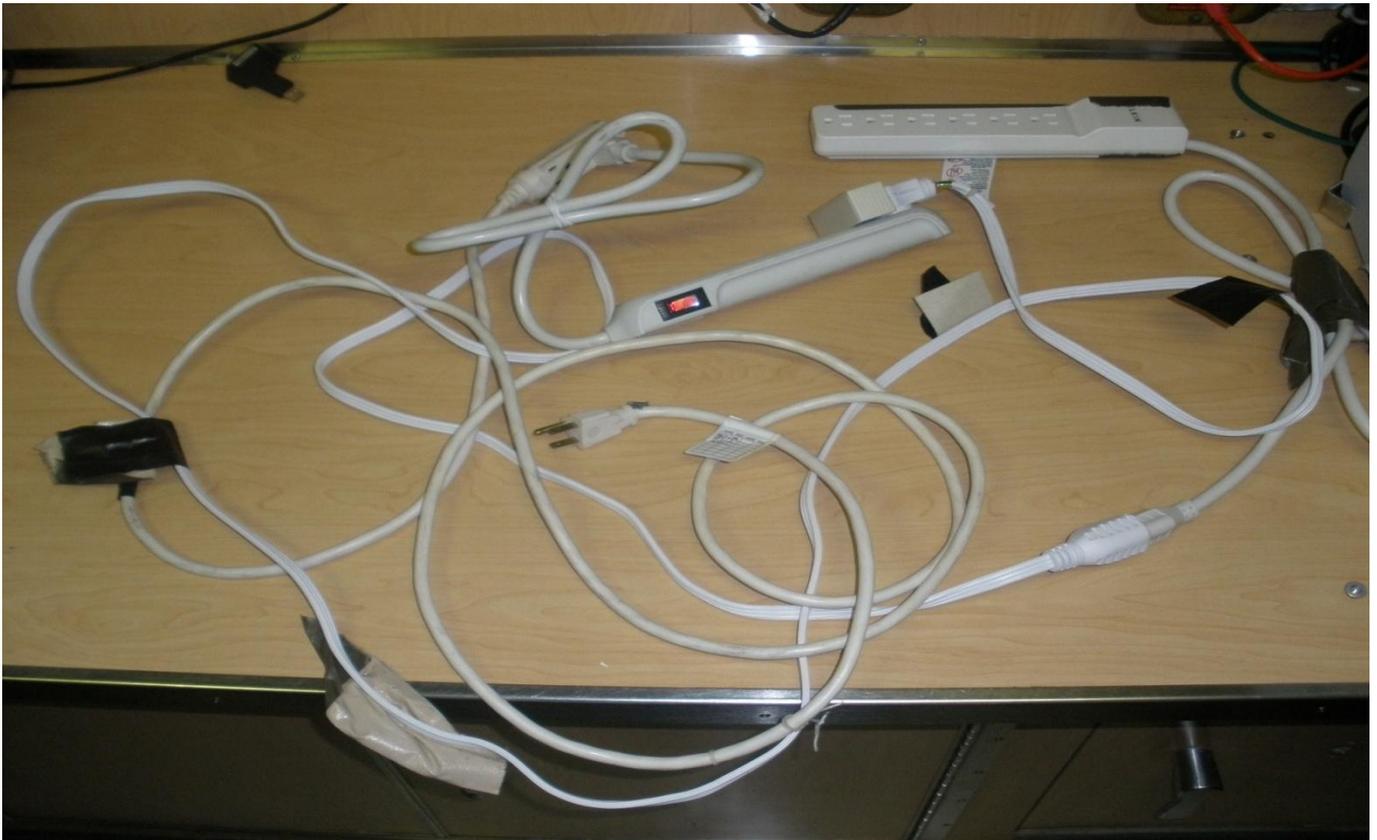
This ridiculous daisy-chain was found in berthing aboard a submarine during a recent Safety Survey.

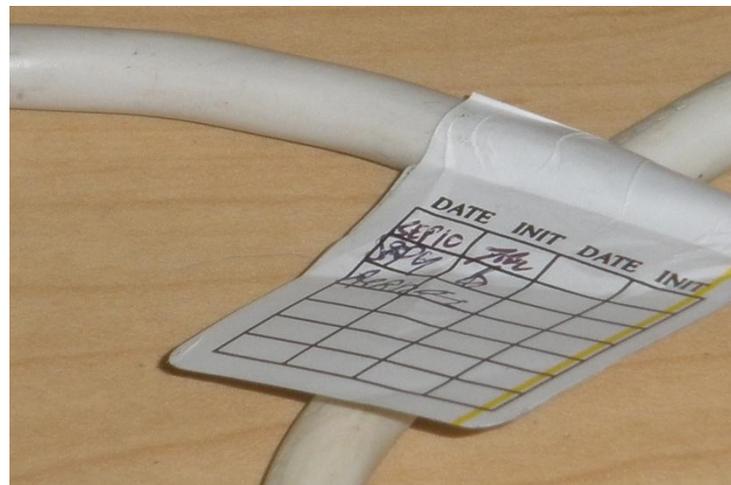
From above, unauthorized surge protector that erroneously passed three electrical safety checks.

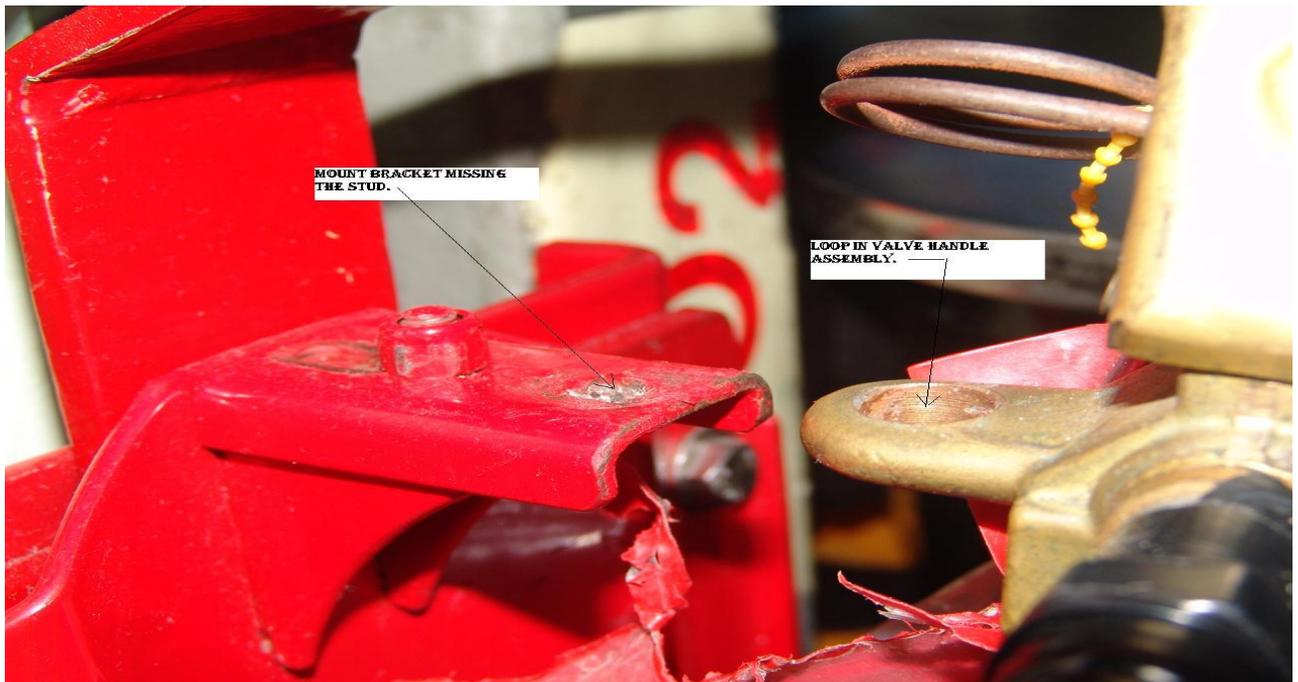
Look closely at the CO₂ fire extinguisher picture on the next page and see if you can find what is missing. As you can see the hanger hook attached to the bracket has broken off. This prevents the loop on the valve handle from making proper contact and fully securing the fire extinguisher. I see this type of condition on boats about once per survey. The material condition below does not support a satisfactory "stowed for sea" condition. Refer to MIP 6641/101 Q-2 (piece #19).
