# FLASH

Factual Lines About Submarine Hazards

April - June 2011

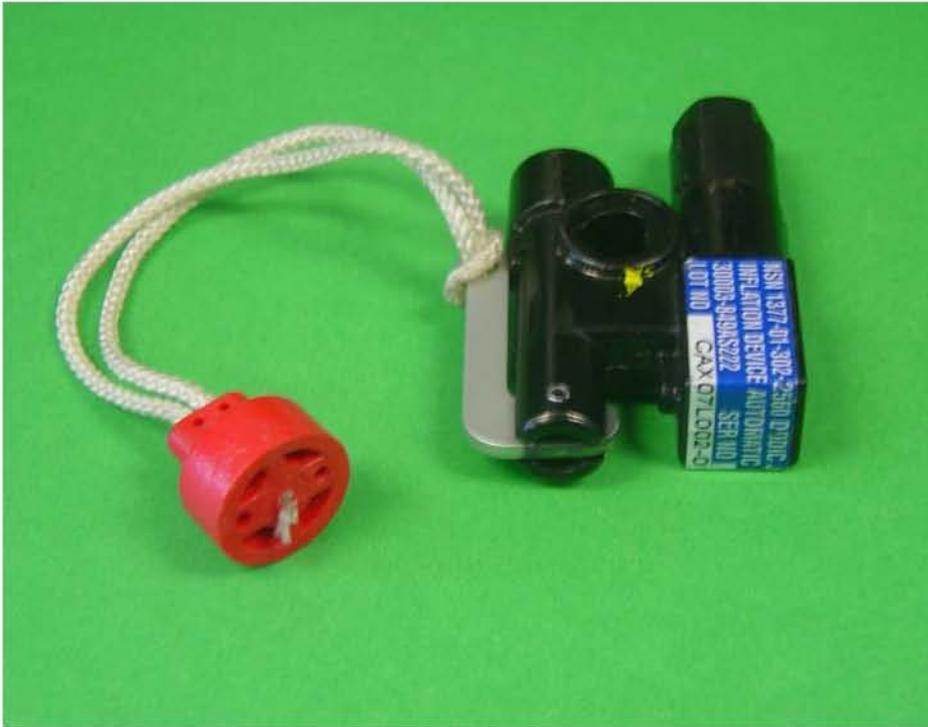
Year= 07=2007

Month = L=November

During recent surveys, I talked with Sailors who recommended information be provided on determination of service life for CONAX inflators. So, in the spirit of FLASH suggestions, here is the information. AEL 2-330013101 Life Preservers Subs (Revision date of Apr 11) includes a note stating service life of new CONAX inflator is five years from the date it was manufactured. This date has been extended via NAVSEA to 7 years pending Naval Ships' Technical Manual Chapter 077 Personnel Protection Equipment (NSTM 077) update. The date can be determined by the lot number just after the "CAX" is a two digit number - that is the year it was made. The letter after the number represents the month: A= Jan, B=Feb, C= March, D= April, E=May, F=June, G=July, H=August, J= Sept, K=Oct, L=Nov, M= Dec (The letter "I" was not used for the month designation).

NAVAMMOLOGCEN MECHANICSBURG PA (Notal), AMMO INFO NOTICE 034-2011, 141940Z Feb 11 CONAX Battery Cap message paraphrased calls for replacement of CONAX inflators with black sensor cap that holds the 12volt battery in place. The sensor cap needs to be replaced with a beige/gray cap that has more torque in the spring to hold the battery. Each submarine will determine required replacements to include total number of vests onboard as replacement cap does not have an NSN assigned for normal ordering requisition (Example submarine has 35 onboard then 35 will be replaced at no cost). The new sensor caps must be requested by email to [sandra.yandell@navy.mil](mailto:sandra.yandell@navy.mil). Please provide quantity, complete mailing address and POC for delivery. The black cap shall be replaced within the next 180 days following the receipt of order.

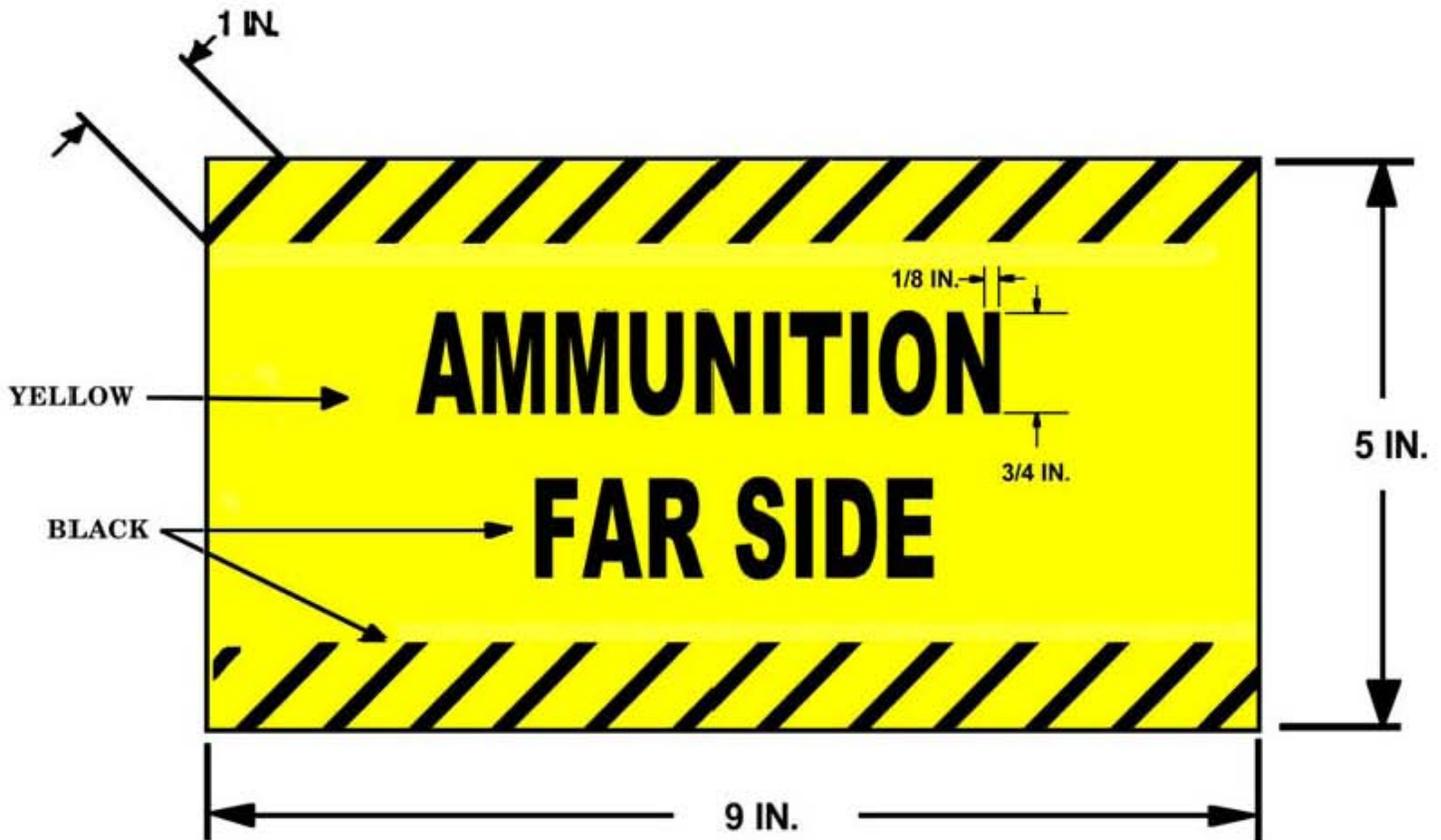
62% of the submarines surveyed are not fully accomplishing the daily MRC associated with the "Ammunition Far Side" sign for the small arms locker. The sign should be located under the small arms locker on the torpedo room starboard side in the overhead. NAVSEA OP 4, Ammunition Afloat, states, "Ammunition Far Side signs shall be posted on the external side of all boundaries of ammunition stowage spaces except for those outside surfaces which are visible from the exterior of the ship." If you do not have replacement signs, they can be manufactured IAW OP 4 using the following specifications: The signs shall be paint-stenciled labels, painted signs, or permanently affixed adhesive reflective labels with a yellow rectangle, a minimum of 5-inches high by 9-inches wide. 1 inch black slanted lines are required along the top and bottom edges, not to obscure the letters. Letters shall be black, a minimum of 1/8-inch thick and 3/4-inch high. Markings on bulkheads shall be placed 5 feet above the deck and spaced 12 feet apart horizontally, if possible.

With the new aft small arms locker being installed, All units should ensure proper signs are being used and ensure proper placement of the signs throughout the ship.

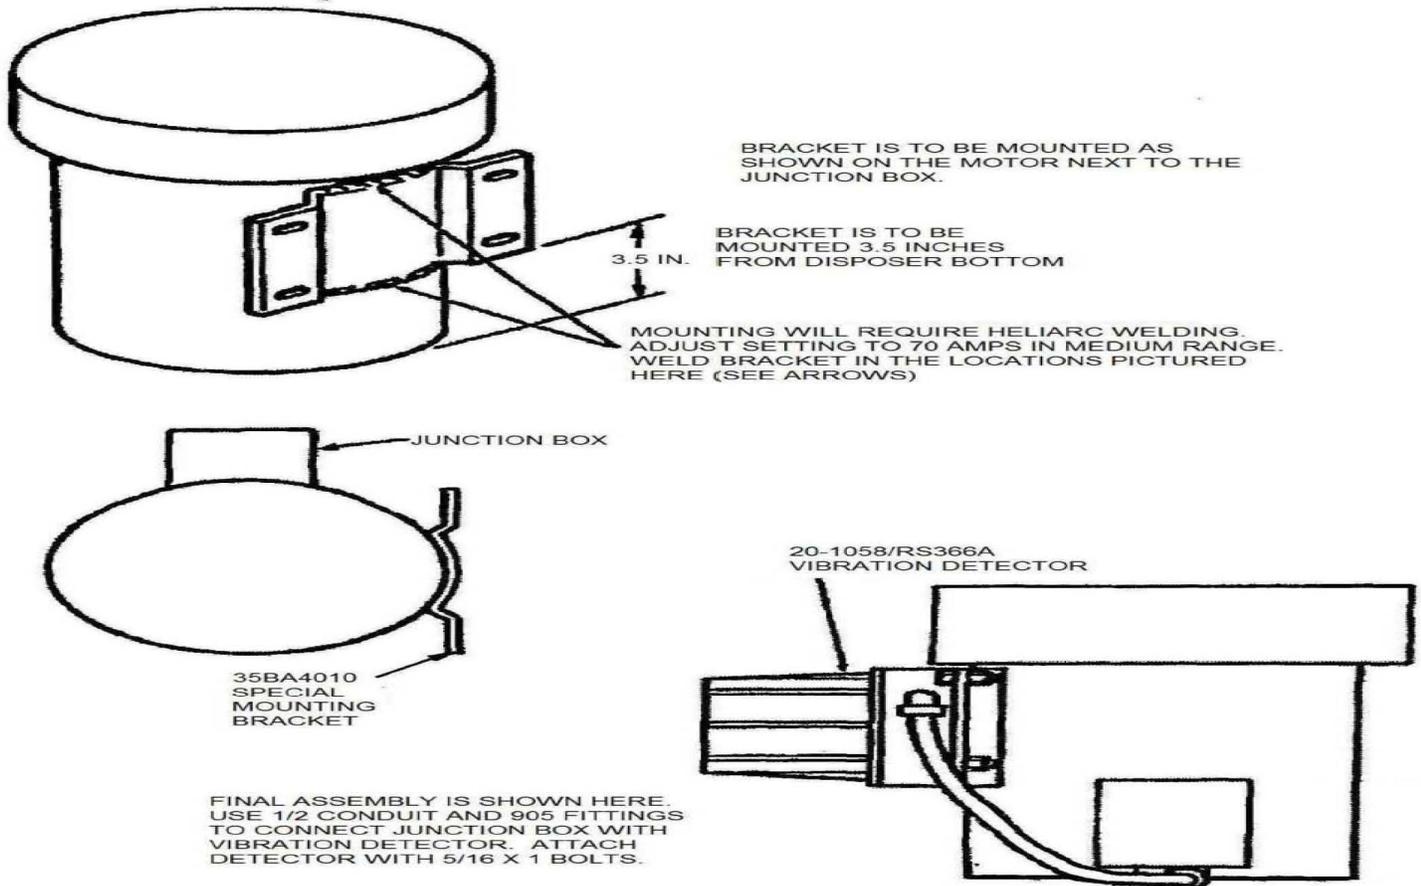
INSTALLATION OF VIBRATION DETECTION BRACKET

During the past six months, our surveyors have uncovered a persistent problem regarding potential electrical shock hazards associated with the galley garbage grinder and vibration detection bracket. A&I N3399 is guidance on the proper installation of the garbage grinder vibration switch bracket and grounding wire for both the operational and spare garbage grinders.

1. Tack weld a collar stud (3/8-16UNC-2A x 1-3/8 L (MIL-S-24149/1-542), NSN 9Z 5307-01-225-7814) to the support leg closest to the vibration switch bracket.
2. Fabricate a grounding wire using:
  - a. (1 pc, approx 12") Green number 8 gage stranded wire (MIL-W-16878/5BNL5) (NSN 9N 6145-01-429-8500)
  - b. (1) Lug, un-insulated, crimp, 8 AWG barrel, 3/8 hose (NSN 9G 5940-01-035-8776)
  - c. (1) Lug, un-insulated, crimp, 8 AWG barrel, 1/4 hole, (NSN 9G 5940-00-828-7199)
3. Install the grounding wire to the collar stud using (1) flat washer (NSN 9A 5310-01-385-7083) and (1) nut (NSN 9Z 5310-00-483-8790)
4. Connect the other end of the grounding wire to the garbage grinder motor housing using existing hardware. Note: remove paint from area of contact between the ground wire lug and motor housing.
