The Navy & Marine Corps Aviation Maintenance Safety Magazine

Summer 2011

**The Navy & Marine Corps
Aviation Maintenance Safety Magazine**
Summer 2011, Volume 50 No. 1

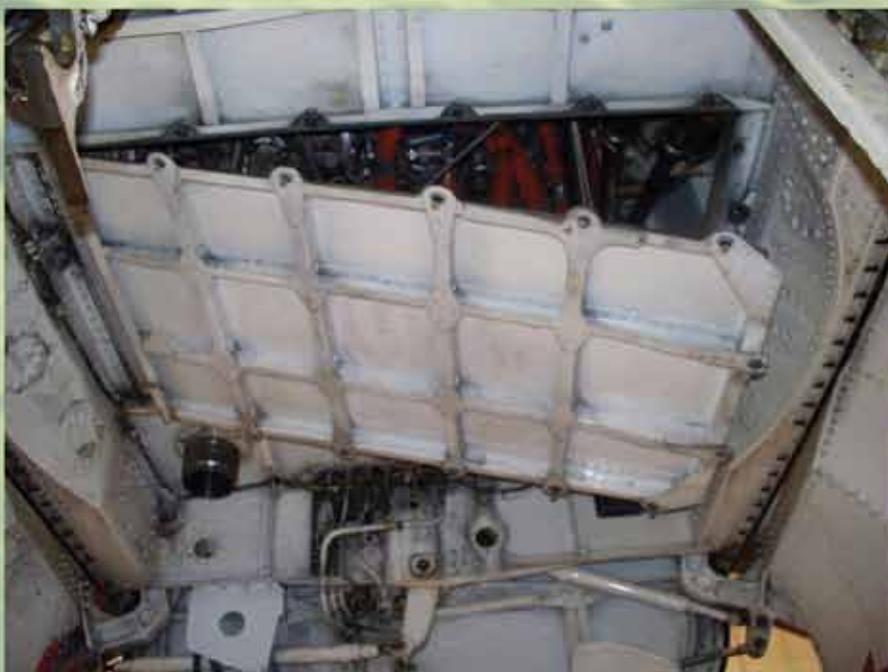
The photo below shows port engine access drop-down panel in the open position wedged against the sidewall of the airframe, (notice the un-secured fasteners).

I could have done several things to prevent this mishap. I thought I'd done a thorough walk-around, although, in my haste, I hadn't. The fasteners that held the panels up in the wheelwell weren't fastened all the way. As the drop check proceeded, they came loose and fell open into the path of the landing gear.

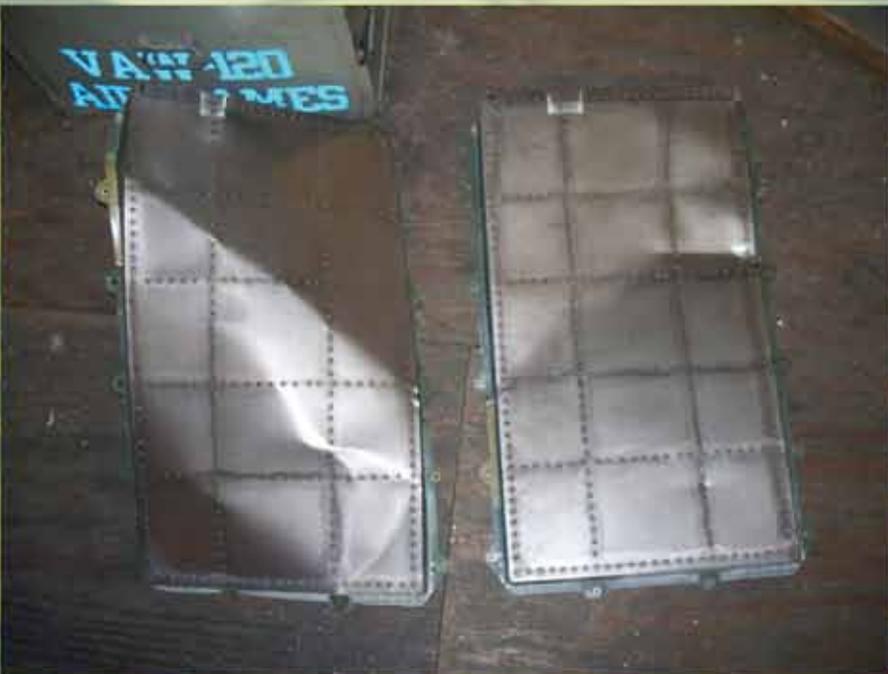
The photo above shows the damage to the inner section of the port and starboard engine access drop-down panels.

As the landing gear was in transition, I heard the sound of crunching metal and signaled for the gear to be immediately lowered. I looked over at the port landing gear and noticed that the engine access drop-down panel in the landing gear well hadn't been in its proper "up" position and was severely damaged. After securing hydraulics to the aircraft, I noticed that the starboard engine access panel had also been damaged severely. Unfortunately, these panels are very hard to come by in the Hawkeye community.

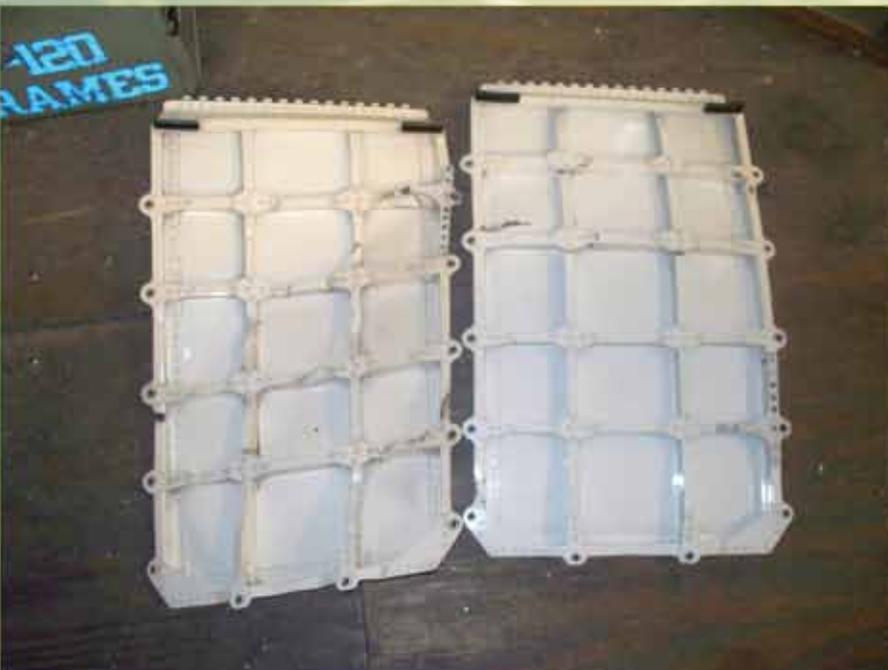
The damage to the outer section of the port and starboard engine is clearly visible in the photo below.

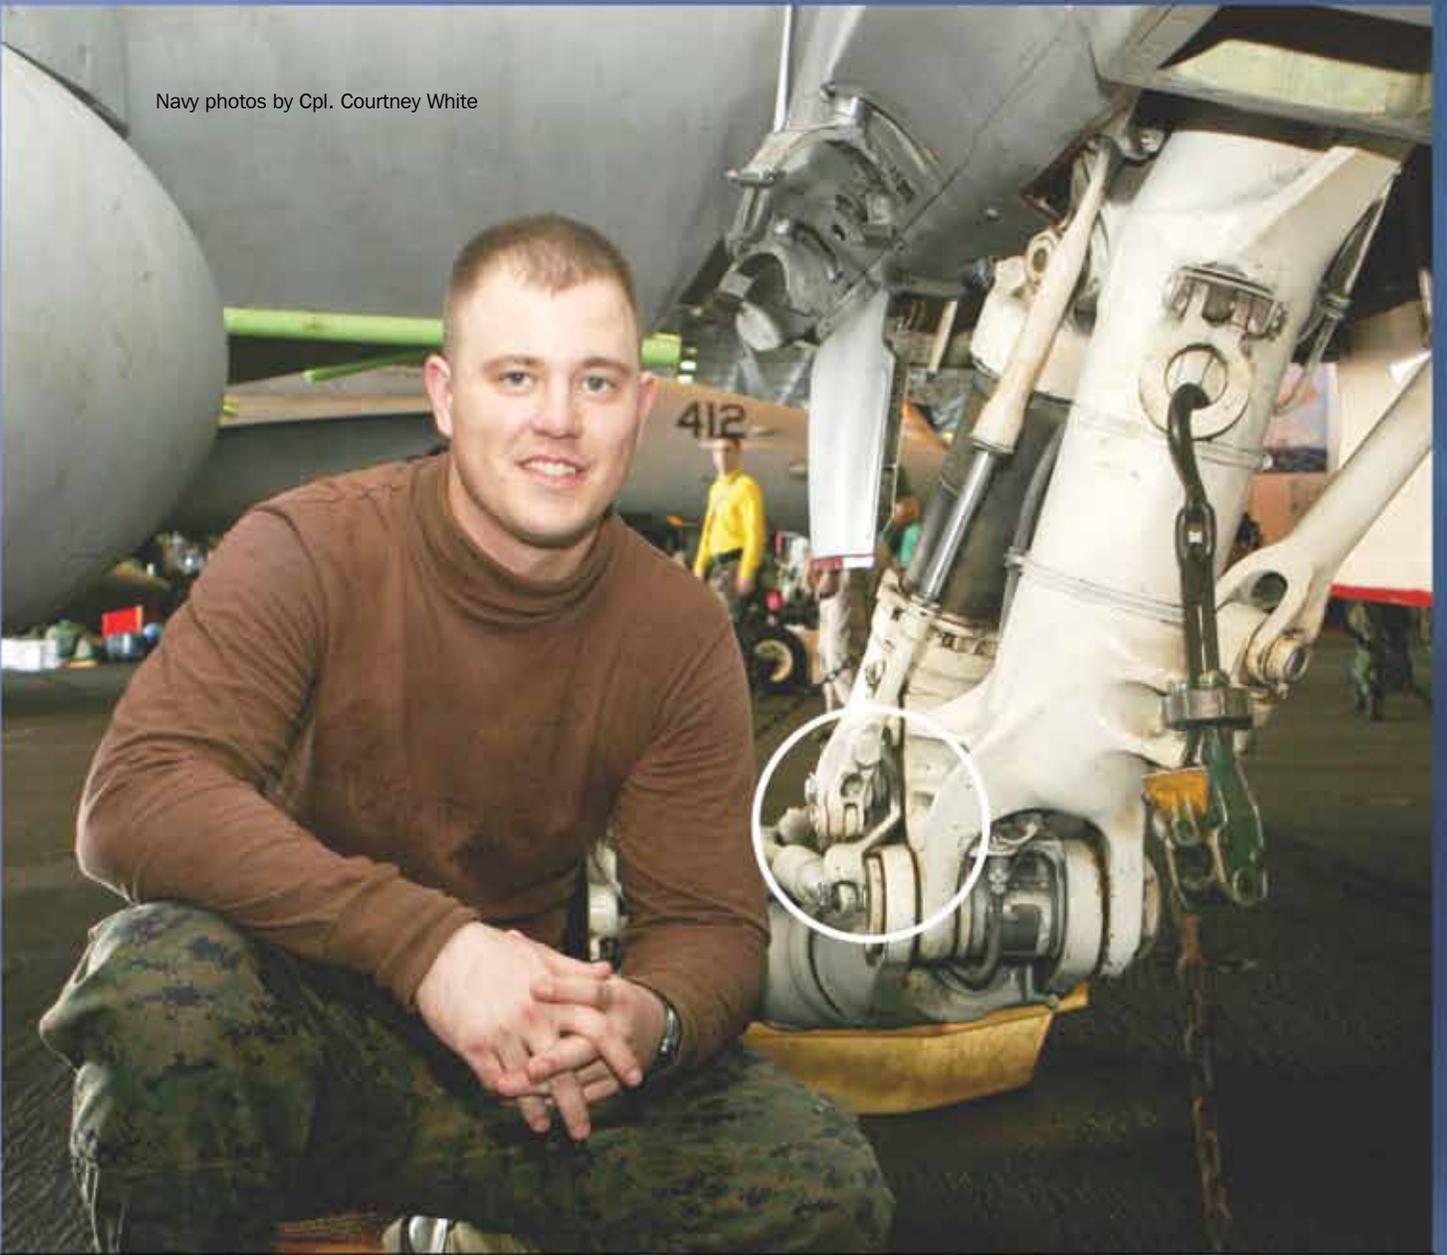
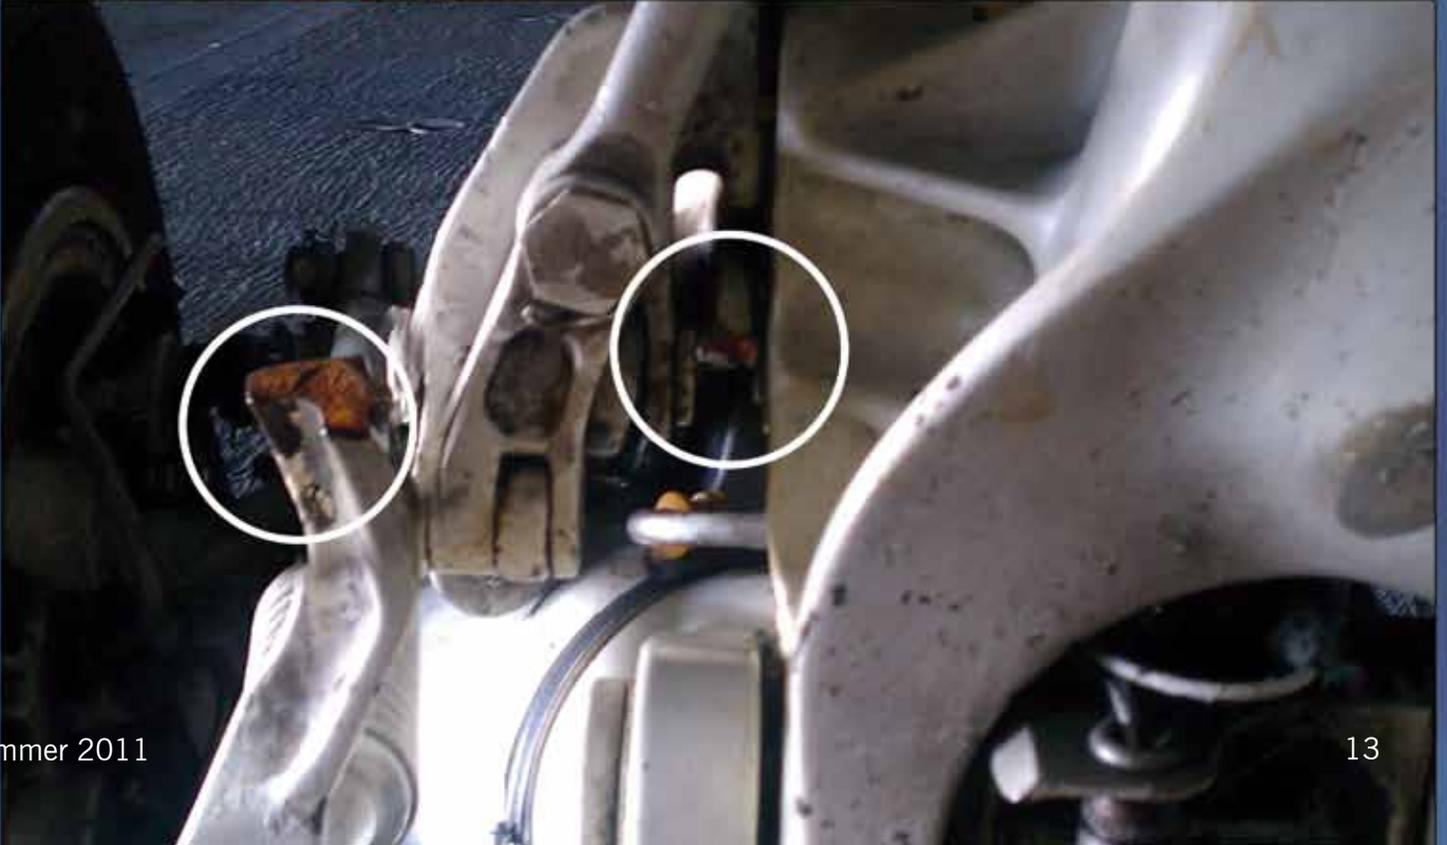
Cpl. Butler kneels beside the landing gear with its fixed planing link (circled, top right). The broken planing link parts (bottom right, circled).

After the normal start-up routine, I saw the plane captain looking around for the final checkers. Using standard hand signals, I asked him if I could proceed with final checking 413. He gave me the thumbs up, so I started at the nose and proceeded down the right side of the fuselage. I made sure that the fasteners were tight, secured the safety wire on the nose tire, and checked for fluid leaks in the wheelwell. I continued around the right wing of the aircraft until finally making it to the right main landing gear. I inspected the tire then pulled and twisted the shrink link. All was well, and I did the same to the planing link. But as I pulled and twisted on this link, it fell limply and detached from the landing gear.

I did not fully know the importance of my discovery until conversing with a few Airframe mechanics. They told me that the planing link is a critical component to the landing gear's operation and it being broken could have caused a catastrophic failure upon landing. Upon further investigation of the planing link, we discovered that it had probably been broken for a few days due to the exposed rusted surface on the underside of the link, where it had broken. We were almost finished with our Atlantic Ocean transit and had not flown for four days, so no inspections had been done recently on that aircraft.

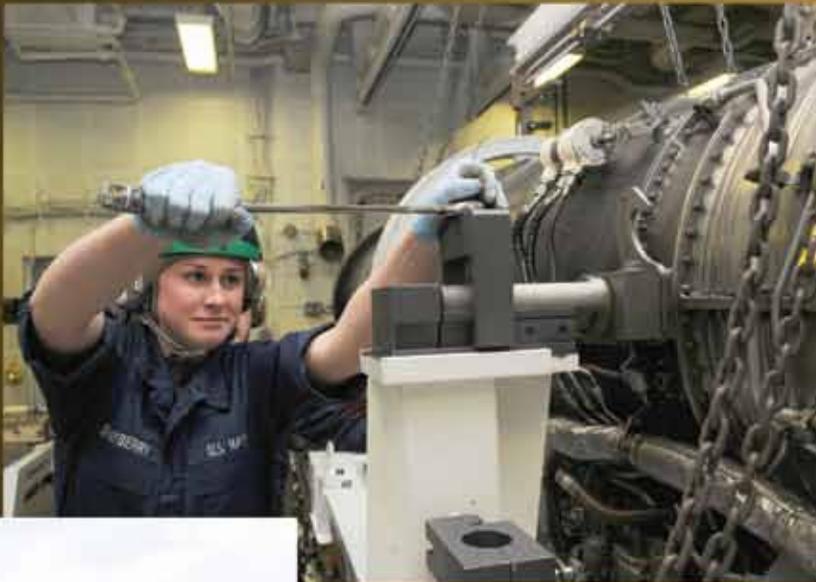
AD3 Seana Sprayberry, tightens an F404 Jet Engine onto a testing mount aboard USS *Ronald Reagan* (CVN 76). Navy photo by MC3 Shawn Stewart.

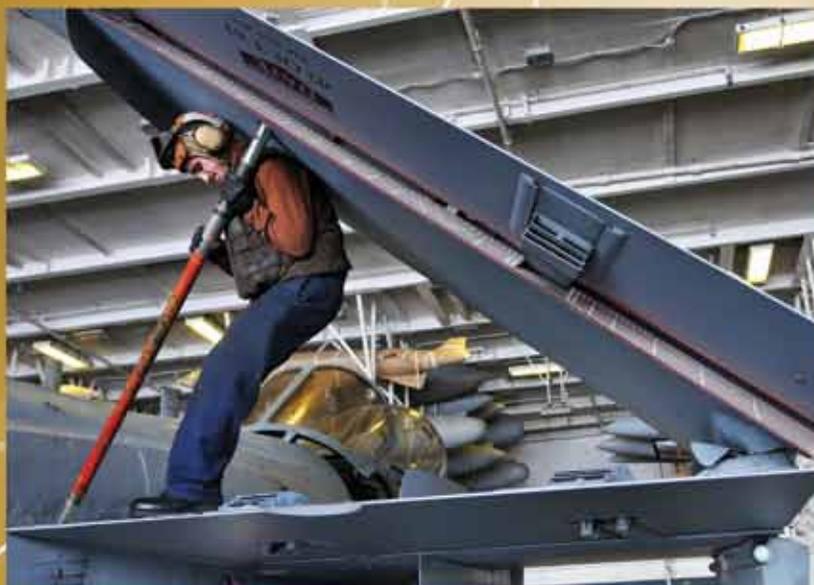
AMAN Alexander Hermann, assigned VAQ-139, screws in wing fold struts to an EA-6B in the hangar bay of USS *Ronald Reagan* (CVN 76). Navy photo by MC3 Shawn Stewart.

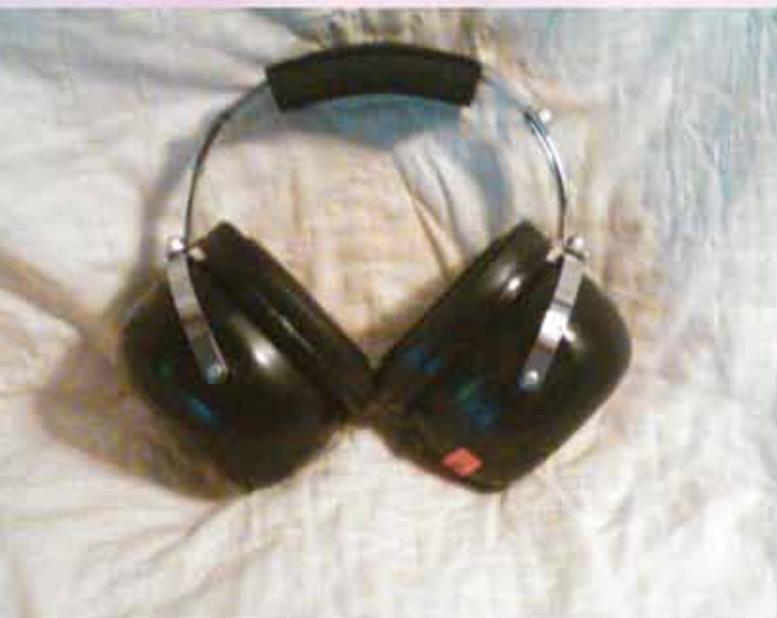
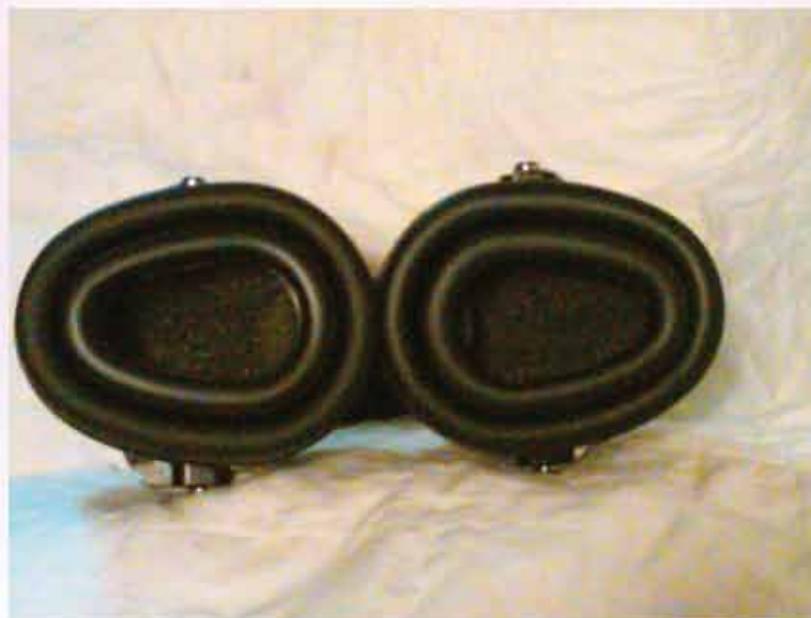
A new and improved hearing protection device to replace the old style (Mickey Mouse) aural protectors is coming to the fleet soon. Known as the DC2, they contain double wall foam insulation between the walls and a double seal on the ear

cups. Designed to fit into existing cranials, the new DC2's will provide better protection from hazardous noise levels as compared to the current style.

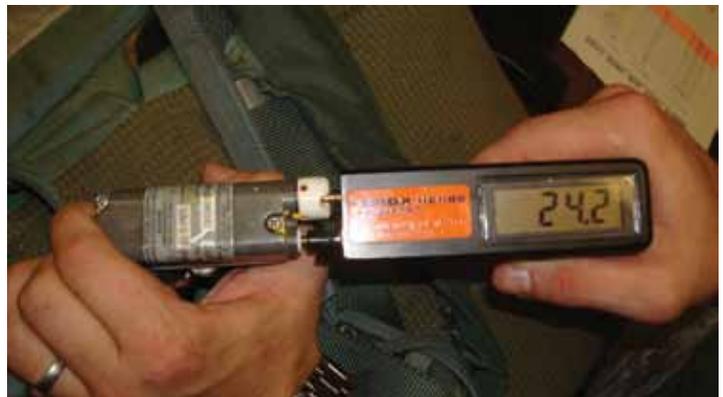
In the 1990’s, the CONAX Florida Corporation manufactured a Battery Voltage Tester that mitigated the risk of contacting probes (see photo). It was subsequently authorized for Navy use and many work centers started using them. It was later determined that the CONAX Tester was not safe for use due to HERO (Hazards of

Electromagnetic Radiation to Ordnance) testing failures. Most importantly, it was not to be used onboard ships or near EA-6B aircraft because of the different radio frequencies being used around the aircraft. This resulted in a recall by the Lakehurst Support Equipment Division. It is not an authorized piece of equipment and hasn’t been for more than 10 years. Yet, one was found in a work center during a recent safety survey.

One such CAUTION in NAVAIR 13-1-6.2 concerns performing battery voltage checks on Parachute Harness Sensing Release Units (PHSRU). It specifically states that only FLUKE 77 series multi-meters are authorized for use, touching meter probes together must be avoided, and all probes must be modified with 3/32 inch heat shrink. The cautions dealing with the probes are clearly explained as, “Failure to do so will result in an inadvertent firing of the PHSRU.” However, the reason for only using FLUKE 77 series multi-meters is not totally clear. Here’s the explanation.
